Research Report
KTC-99-53

EVALUATION OF SUPERPAVE IN KENTUCKY

September 1999

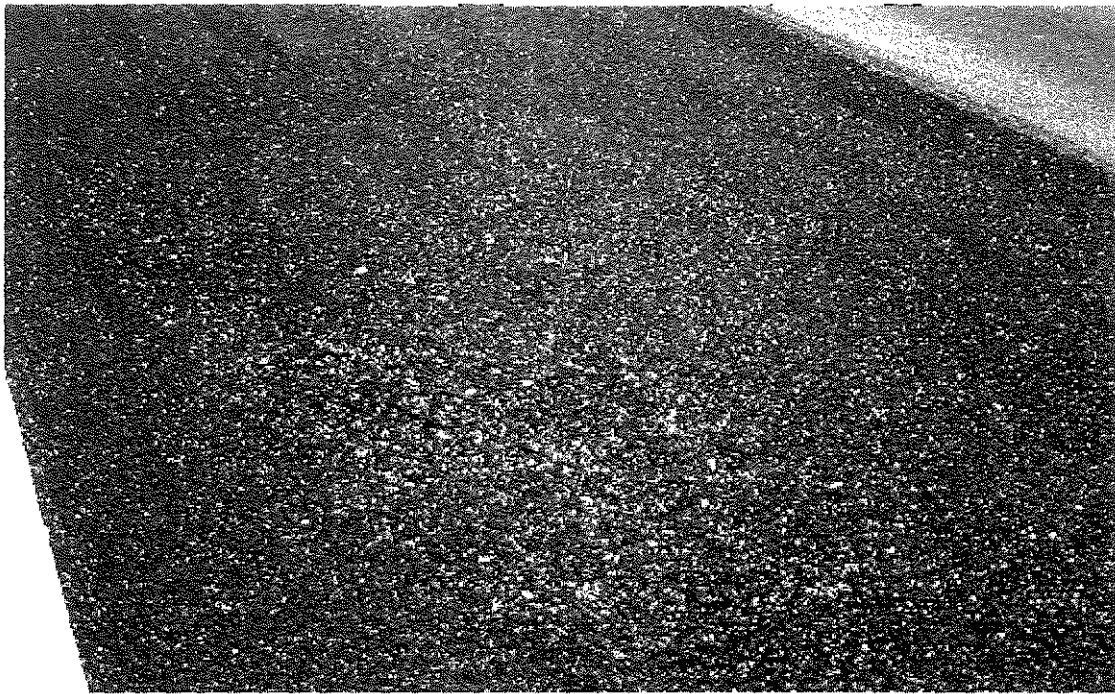
Segregation was noted on approximately 13 percent of the projects (Figures 11 and 12). This occurrence was reported on three of the projects. Segregation was observed at the ends of trucks and also at the centerline of the lane on some of the projects. In each case, a shuttle buggy or materials transfer vehicle (MTV) was not used. Contractors using MTV's indicated that it helped mitigate segregation problems. MTV's were used on 30 percent of the projects. Approximately 59 percent of the pavers were operated with the wings out. Ninety-six percent of the plants loaded the trucks with three drops. In one location on US 68/KY 80, the MTV caused rutting in the base course (Figures 13 and 14). From conversations with Cabinet personnel, it is believed that the subgrade in this area was weak.

Figure 11. Segregation Occurring on US 23, Pike County.

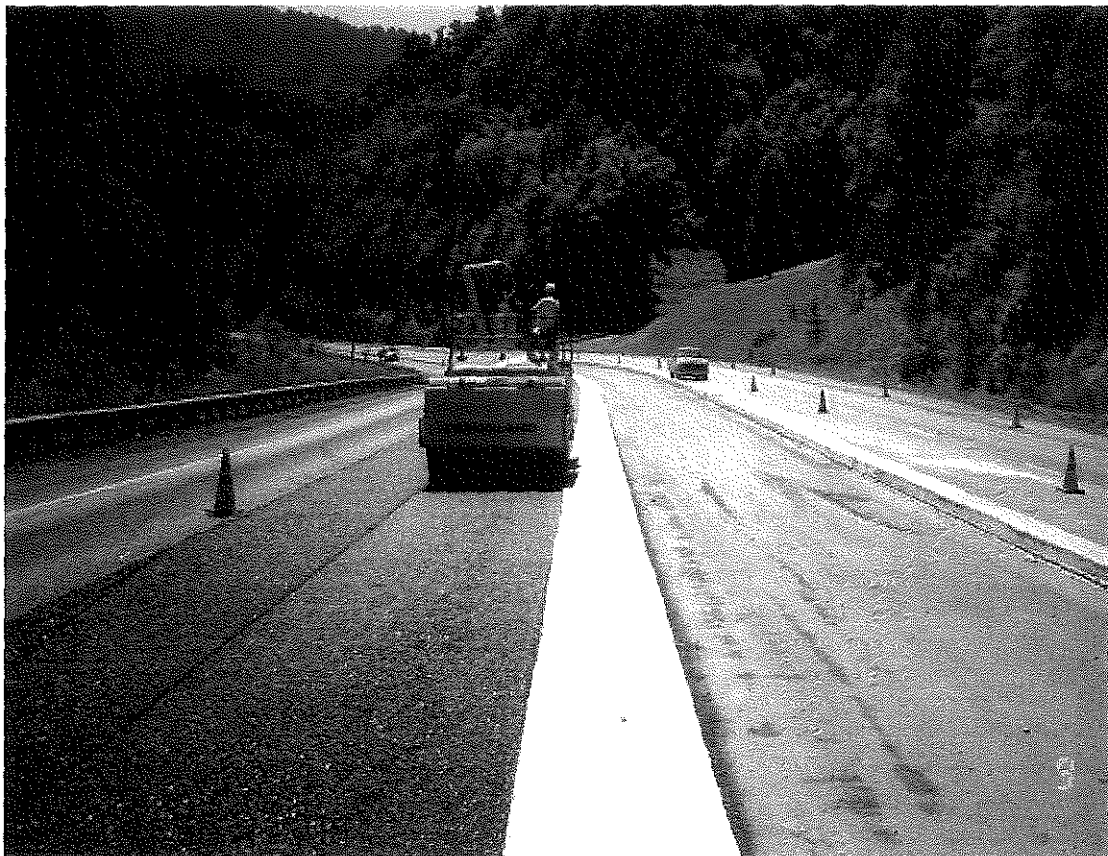
Figure 12. Segregation Occurring on US 23.

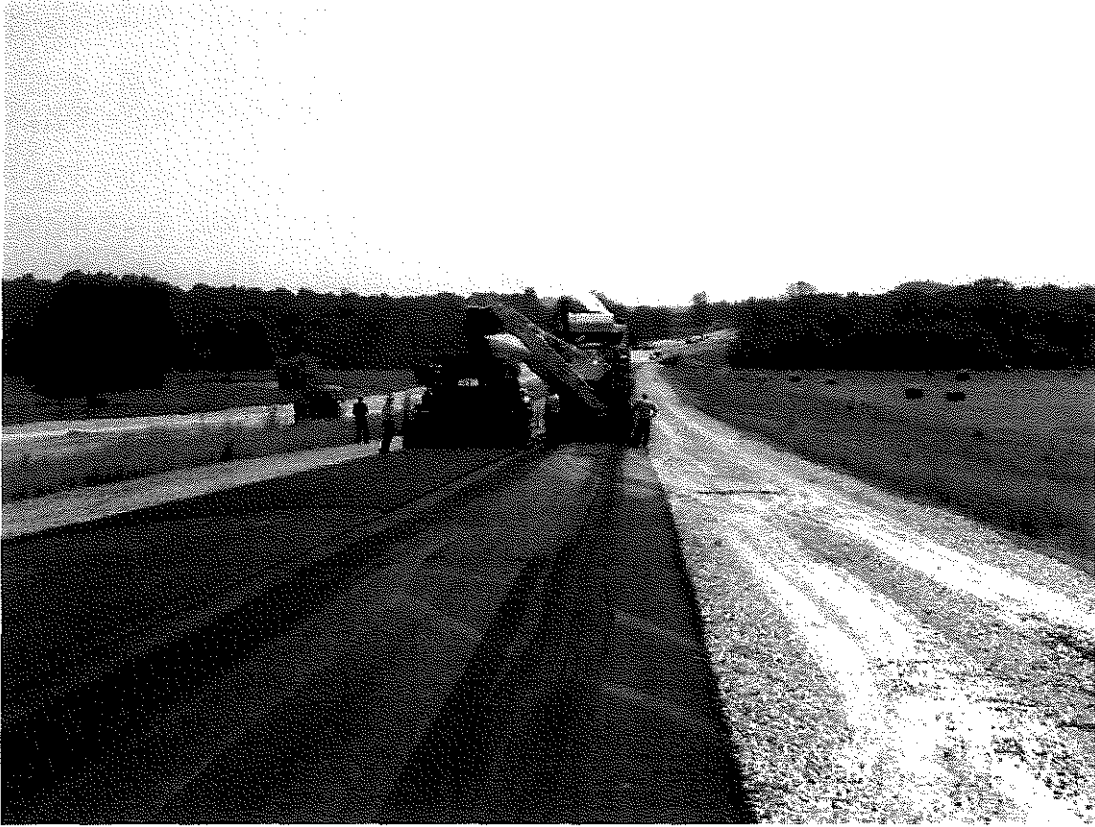
Figure 13. MTV Rutting Base Material.

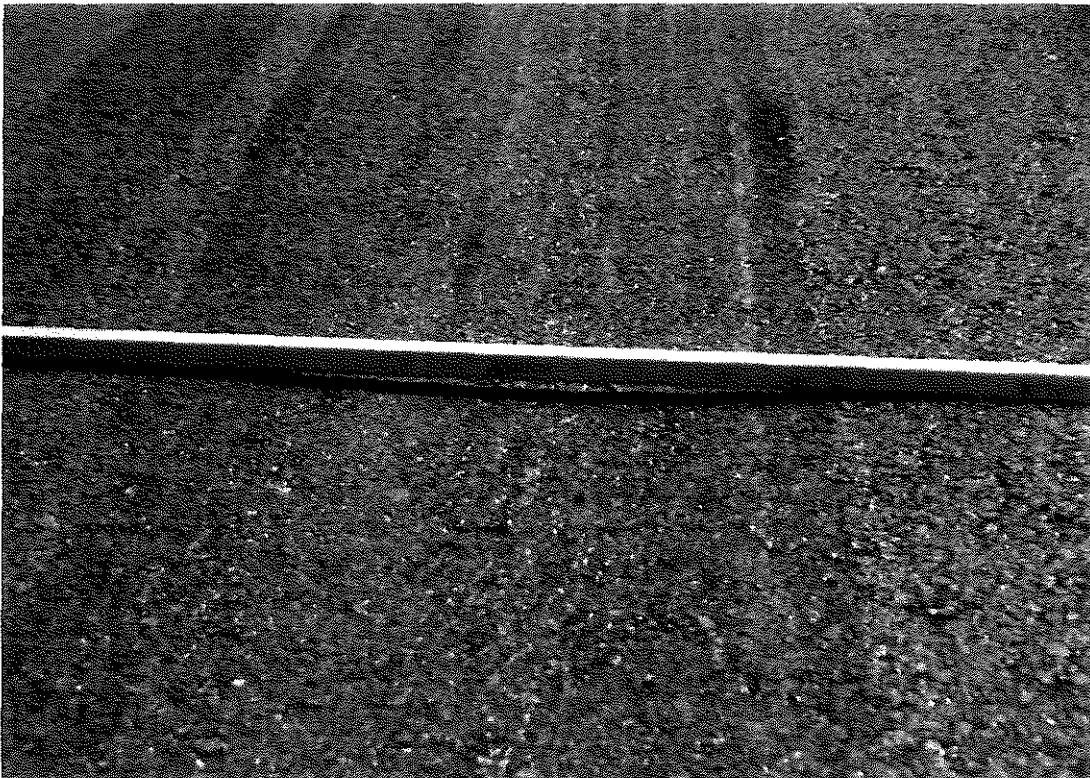
Figure 14. Rutting Caused by MTV.

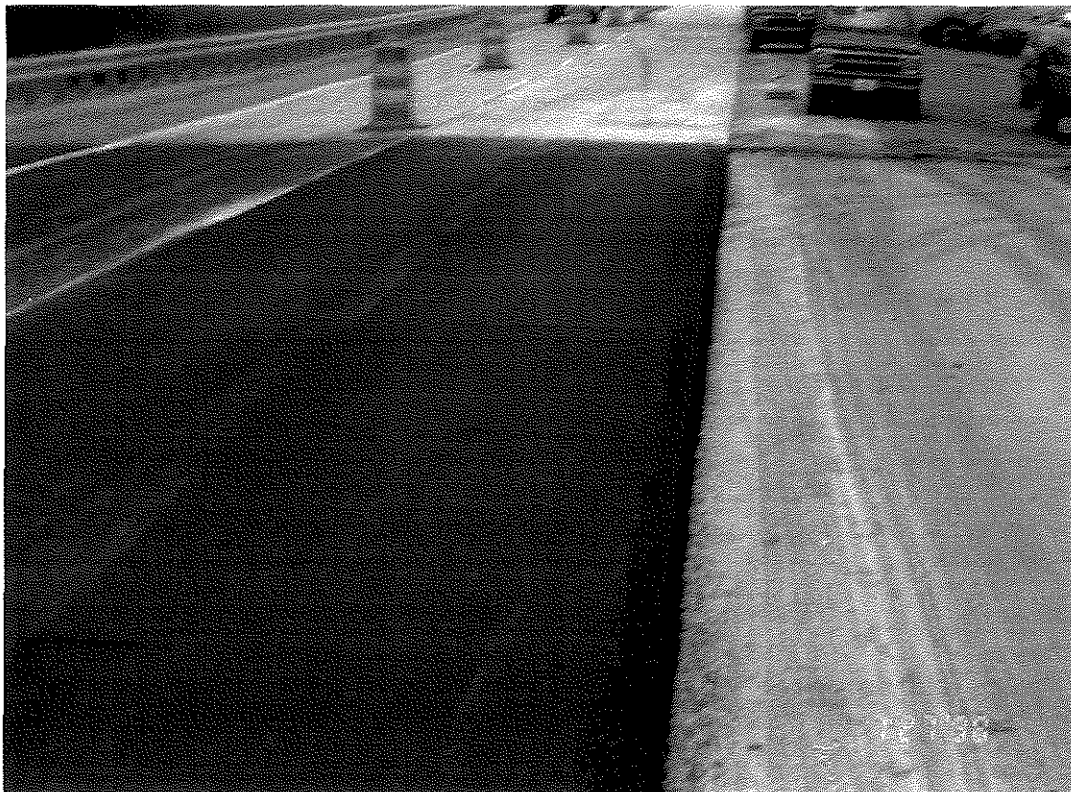
Transverse humps in the final lift were reported or observed on 17 percent of the projects. Humps had occurred on US 60 in Woodford County, KY 4 and I-64 in Fayette County, and US 31 E in Nelson County during construction. On US 60, Department personnel indicated that the underlying geotextile material placed over the joints in the concrete pavement in 1982 may have been heated, which permitted the fabric to delaminate from the concrete. The binder in the mixture was changed from a PG 76-22 to a PG 64-22; lowering the mixing and compaction temperatures eliminated the humps.

Figure 15. Hump Occurring in Mat on Interstate 64.

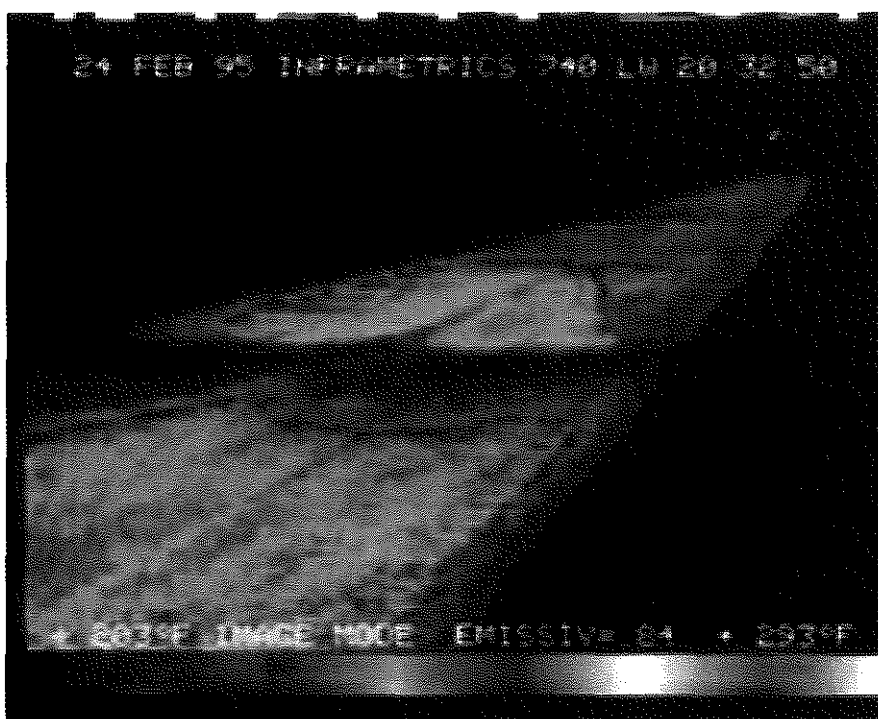
Figure 17 is an infrared scan showing several hundred feet of pavement shortly after placement. The darker horizontal bands are thermal-segregated areas from each truck. The figure also indicates that the edges of the mat cool more rapidly.

Figure 17. Thermal Segregation Observed in Base Being Placed on I-64.

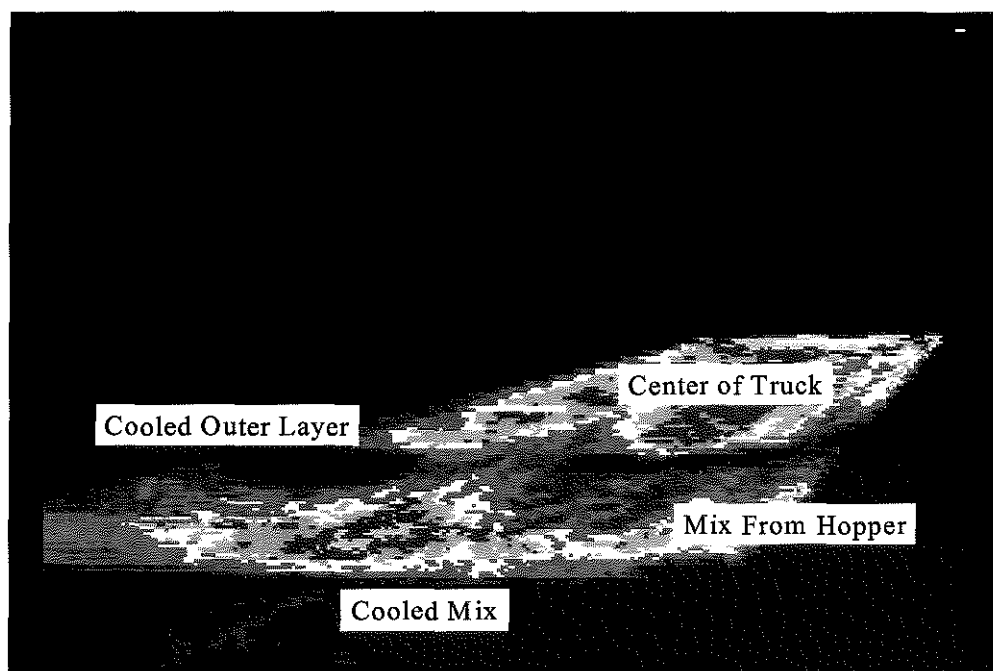
Figure 18 shows a typical thermal scan when a break occurs in the paving train. The previously laid mixture has had time to cool, and the mixture in the hopper has retained a substantial amount of its initial heat. The cool, crusted layer for the new truck slides into the hopper first and is placed, and then the hotter center of the truck is placed.

The I-64 project was placed without the use of a MTV or any additional mixing prior to placement. The net result was that the beginning of each truckload could be precisely located by its thermal scan.

Figure 18. Thermal Segregated Areas in Newly Placed Mix.

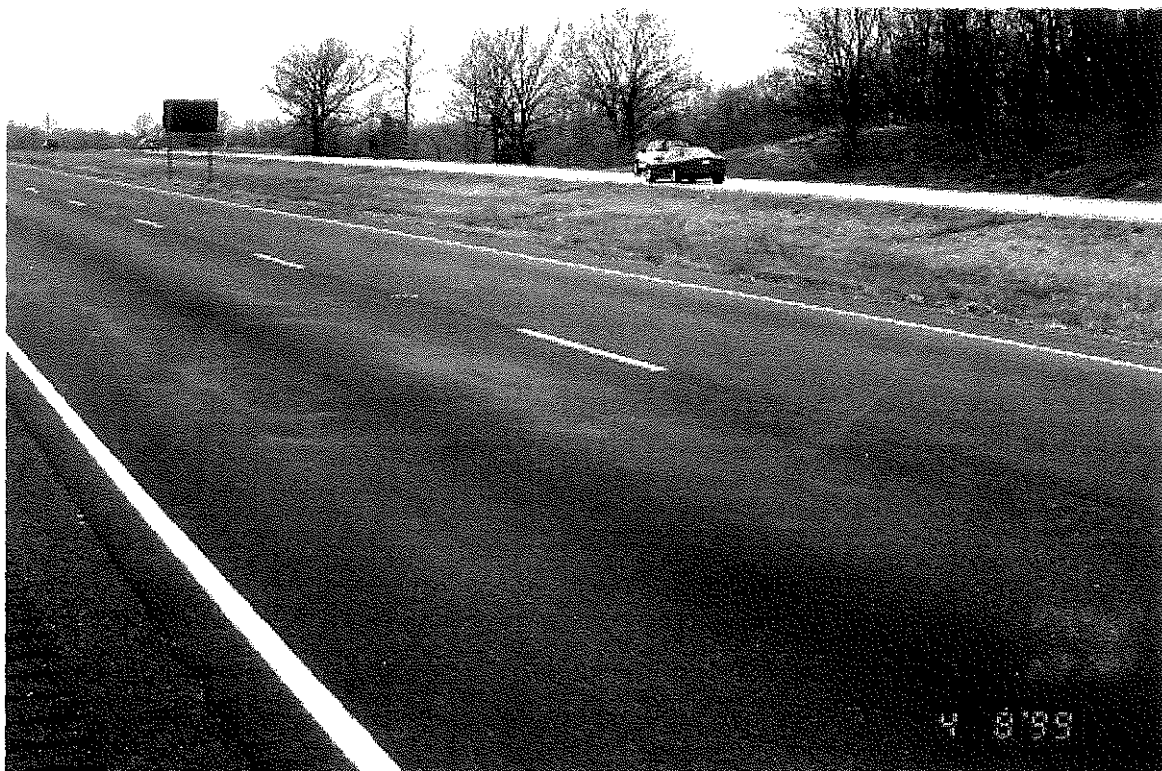
Figure 26. Bleeding on US 641 Near the Intersection of KY 121.

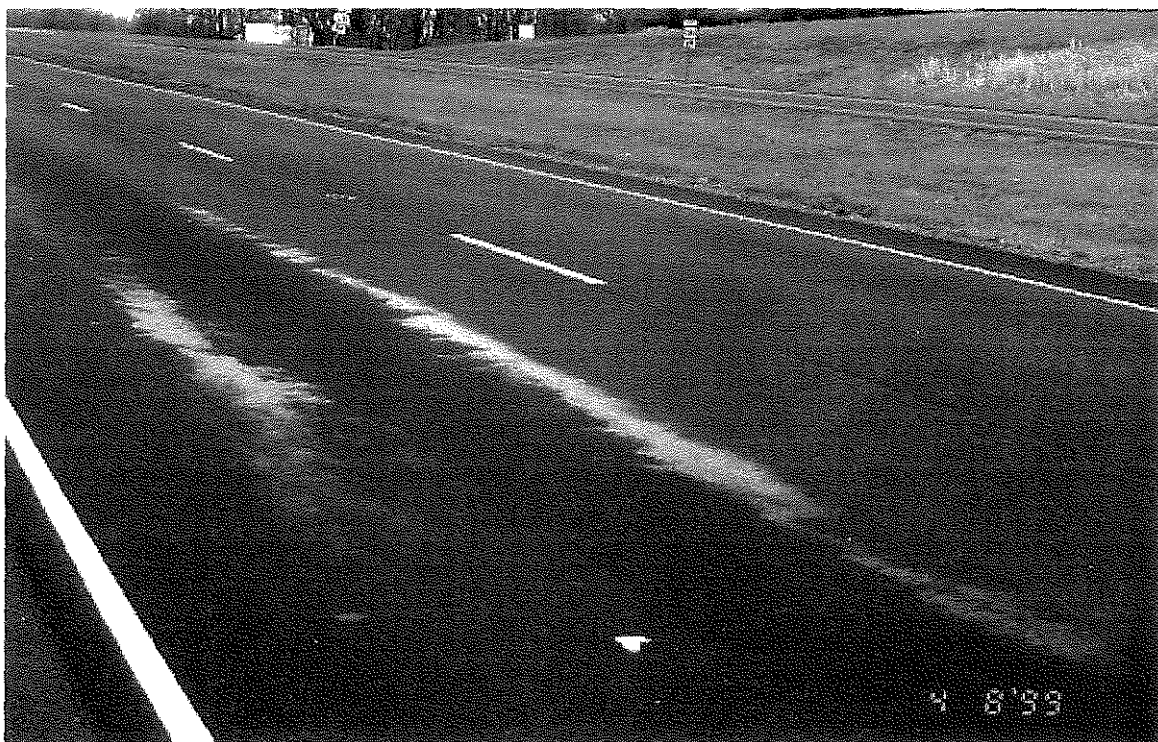
Figure 27. Bleeding on US 641 Near the Intersection of KY 80.

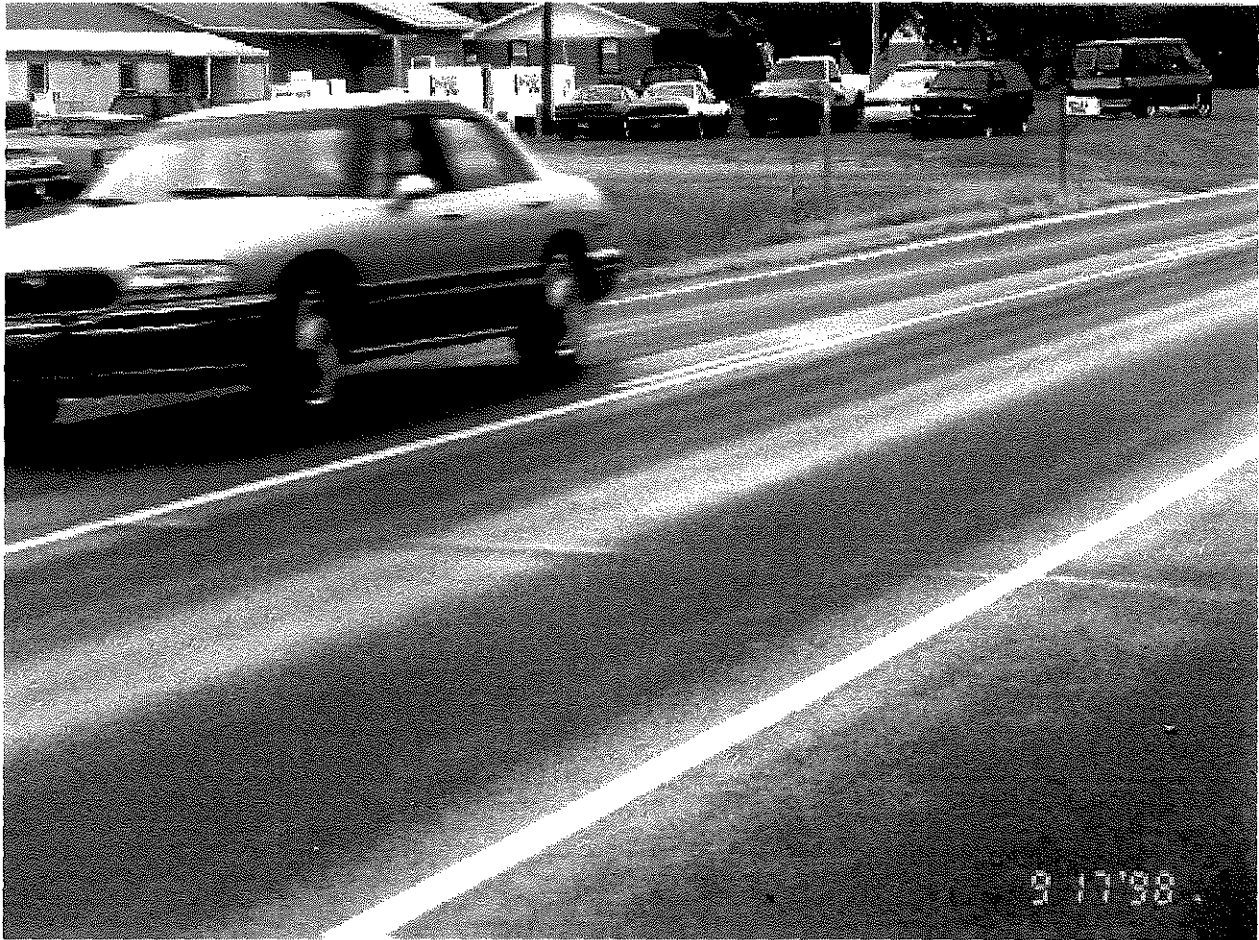
The Marshall County project was completed in July, 1998. The site was originally inspected for performance in August, 1998. Rut measurements taken in August indicated that approximately 75 percent of the project had rutted approximately 1/8 of an inch. Transverse ridges were also observed in several areas (Figures 28 and 29). The site was revisited on April 8, 1999. The areas of rutting had increased, but the maximum depth of rutting had not changed. The transverse humps or ridges had started to crack (Figure 30).

Figure 28. Transverse Ridge in Pavement on US 62.

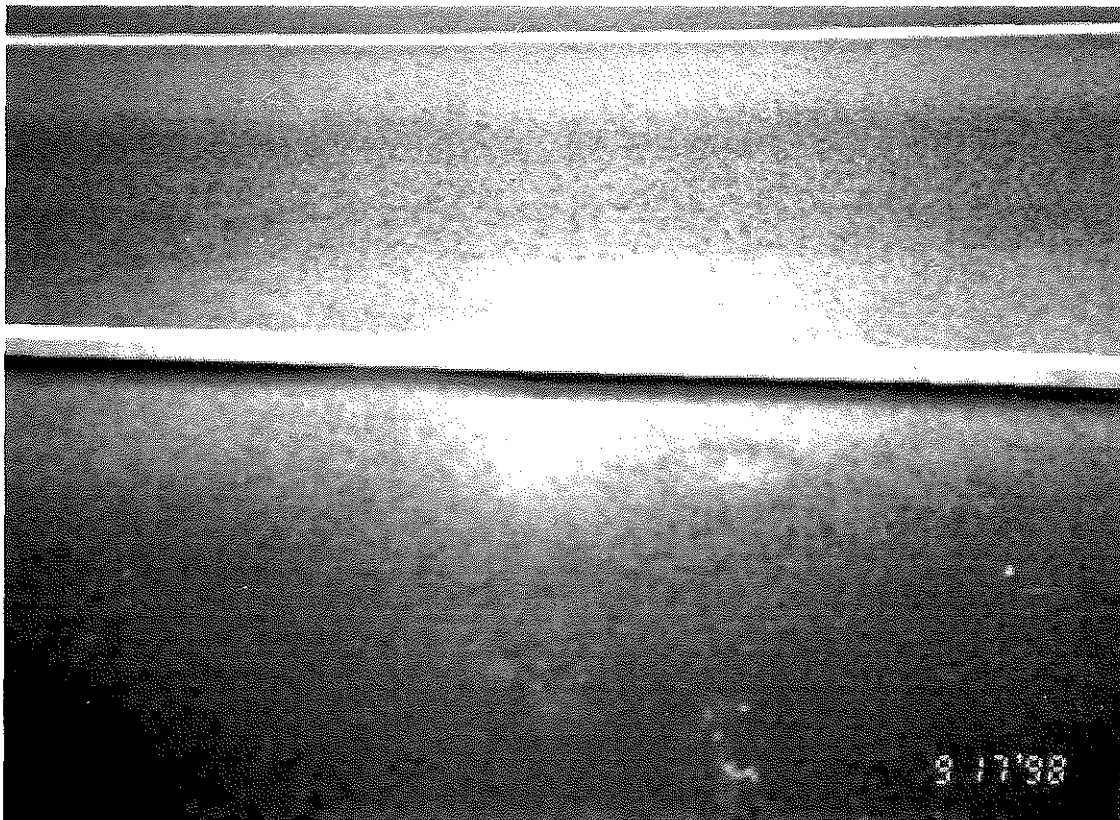
Figure 29. View of Transverse Ridge on US 62.

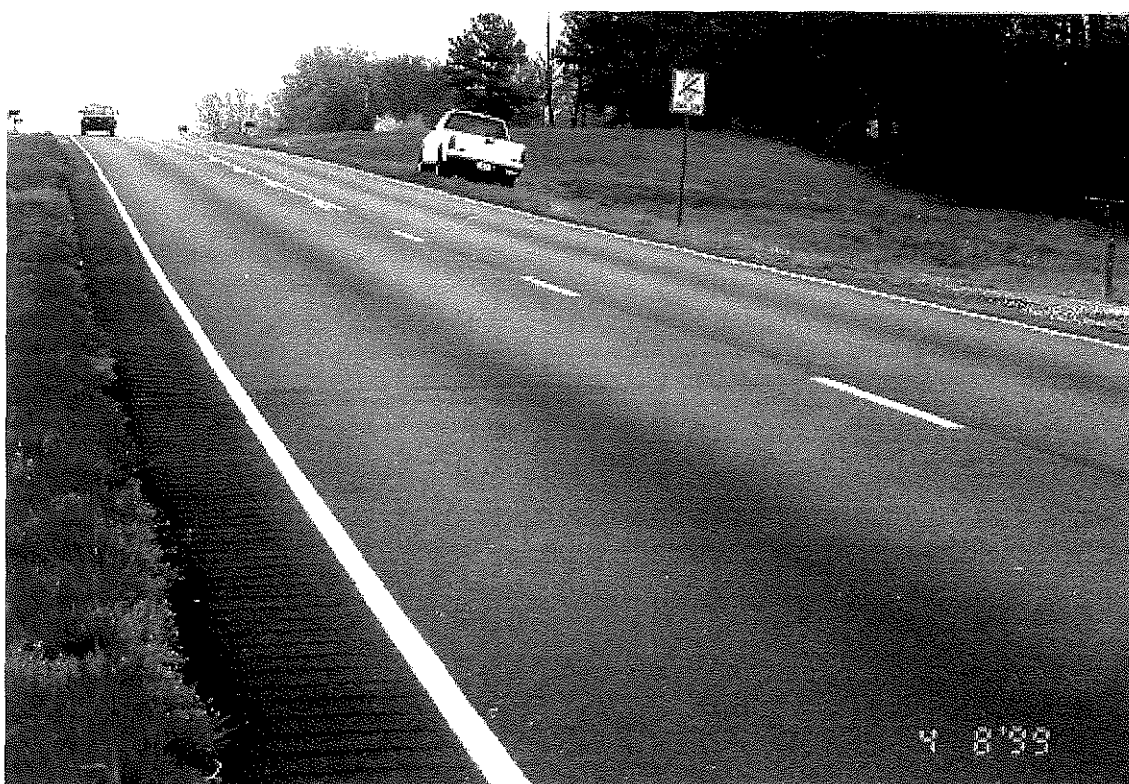
Figure 30. Cracking Occurring in Transverse Ridges on US 62.

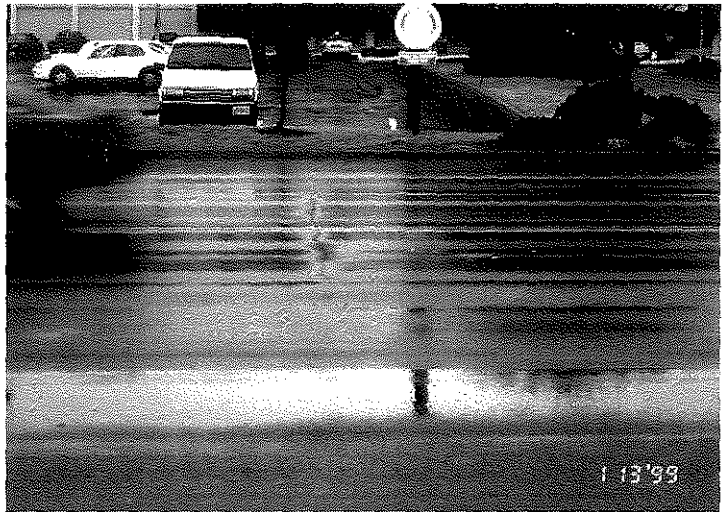
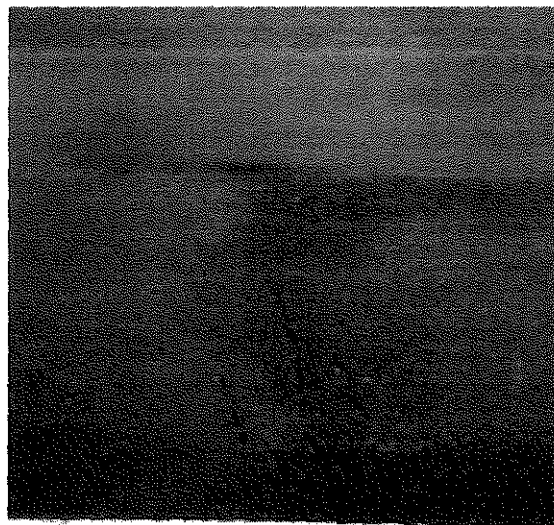
The Jefferson County project was completed in November, 1998. The site was inspected on January 13, 1999. Numerous transverse cracks were observed throughout the project (Figures 31 and 32). It appeared that the transverse cracking was reflective cracking from the old concrete pavement. Rutting was observed in 21 of the 28 locations that were inspected.

Figure 31. Transverse Cracking on US 31W in Jefferson Co.

Figure 32. Transverse Cracking on US 31W in Jefferson Co.

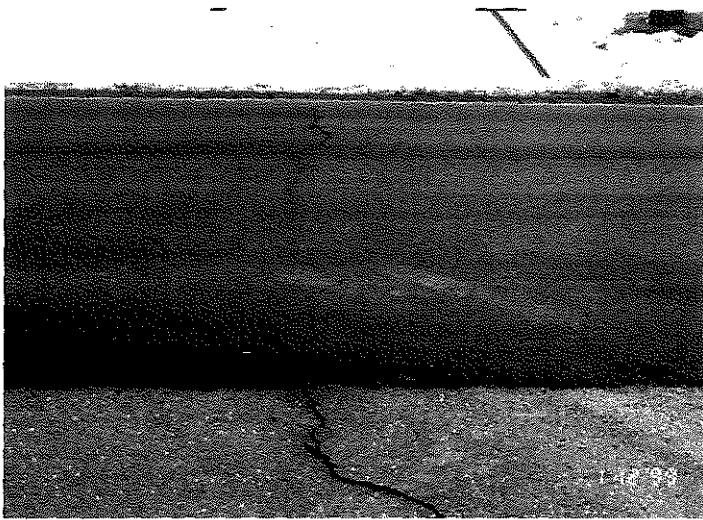
The project was completed in November, 1998. The site was inspected on January 11, 1999. Rutting had occurred in 14 of the 16 locations that were measured. The rutting ranged from 1/16 to 1/8 of an inch. Transverse cracking had occurred throughout the project (Figures 33 and 34). It appears that the transverse cracking is reflective cracking from the old concrete pavement. In several locations, the pavement had risen around the cracking (Figure 35).

Figure 33. Transverse Crack in New Overlay on KY 16.

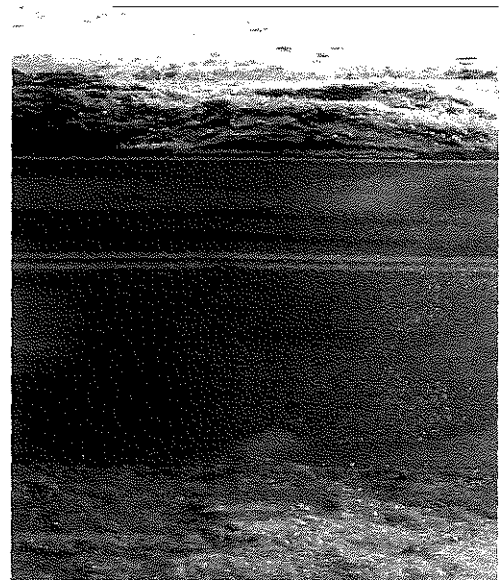
Figure 34. Transverse Crack on KY 16.

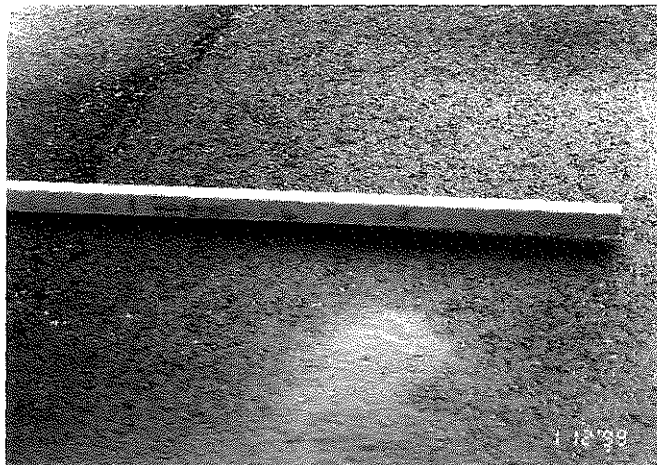
Figure 35. Pavement Raised Around Crack on KY 16.

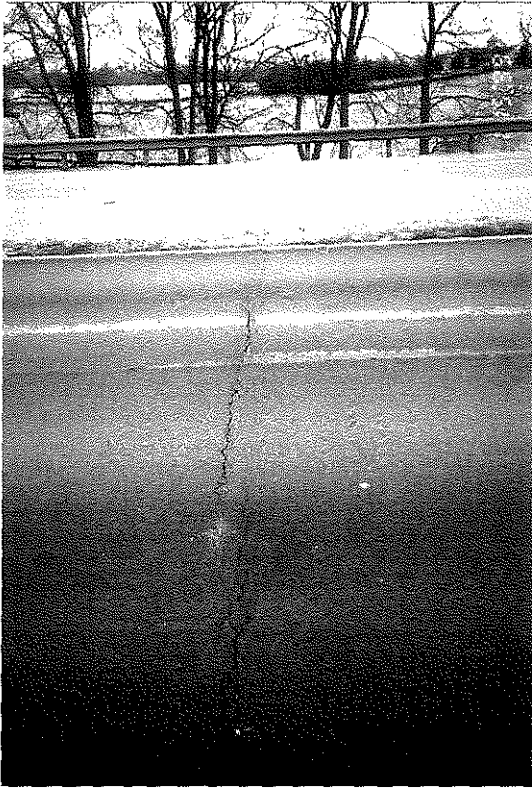
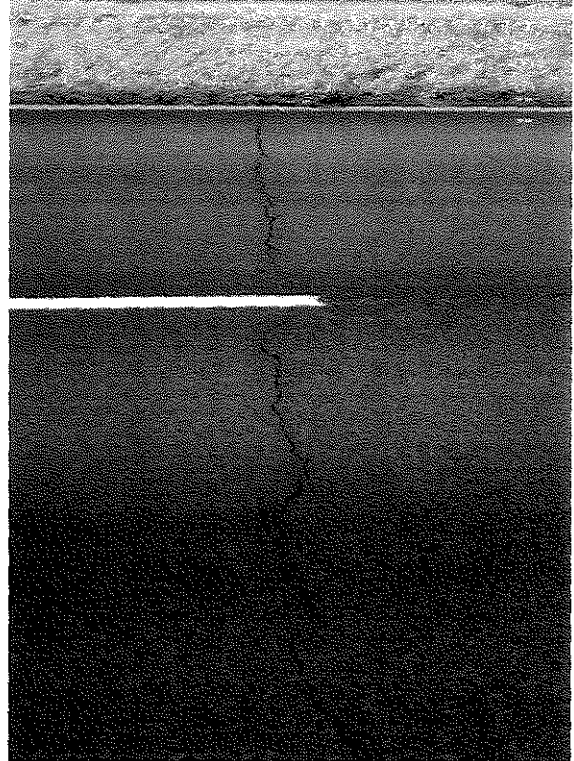
The project was completed in June, 1998. The project was inspected on January 19, 1999. The pavement had rutted 1/16 to 1/8 of an inch in 70 percent of the areas tested. The maximum recorded rut depth was 3/16 of an inch. This measurement was recorded near the start of the project. Transverse cracking had occurred throughout the project (Figures 36 and 37). Approximately 240 transverse cracks were noted. It appears that most of the transverse cracking was reflective cracking from the old concrete pavement.

Figure 36. Transverse Cracking, US 60.

Figure 37. Transverse Cracking, US 60.

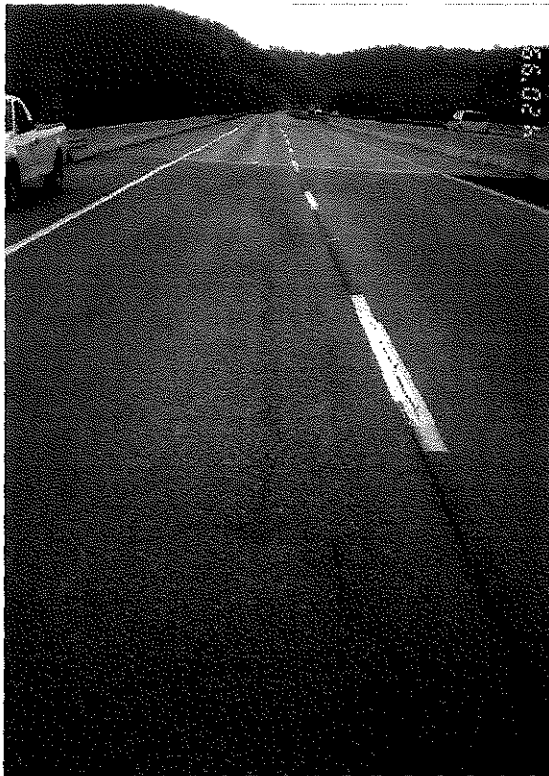
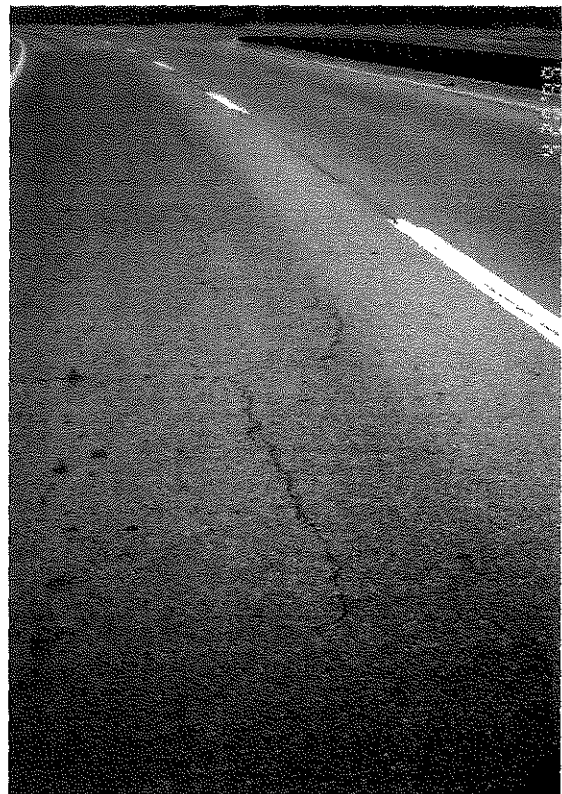
Figure 38. KY 676, Franklin Co.

This project was completed in November, 1995. The project was last inspected on April 20, 1999. The pavement had many longitudinal cracks in the wheelpath and very little transverse cracking (Figures 38 and 39). The maximum rut depth observed was $\frac{3}{16}$ of an inch. The average rut depth was between $\frac{1}{16}$ and $\frac{1}{8}$ of an inch.

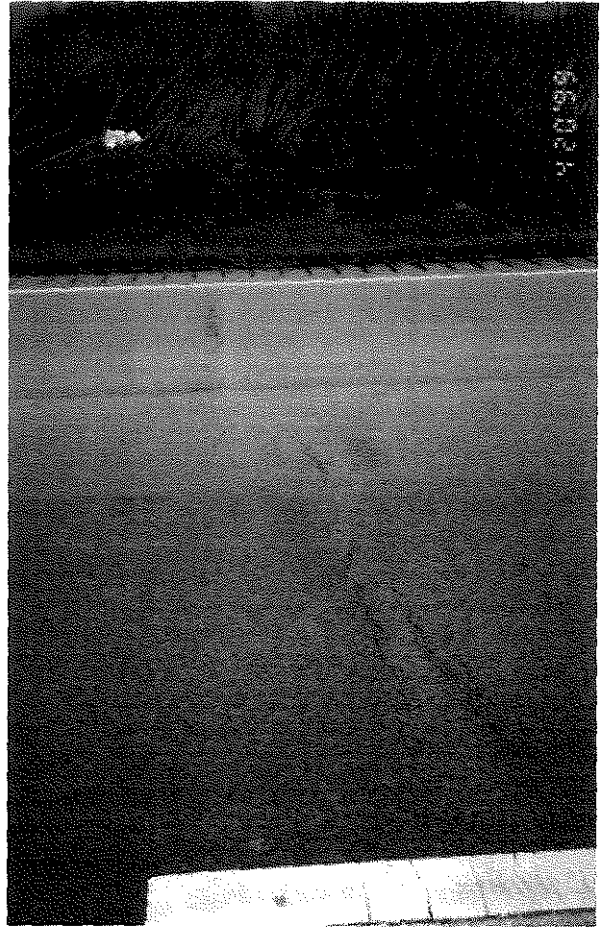
Figure 40. I-64, Shelby-Franklin Co.

This project was completed in July, 1997. The project was last inspected on April 20, 1999. The pavement showed numerous transverse cracks (Figure 40). Rut depths were not obtained at this site.

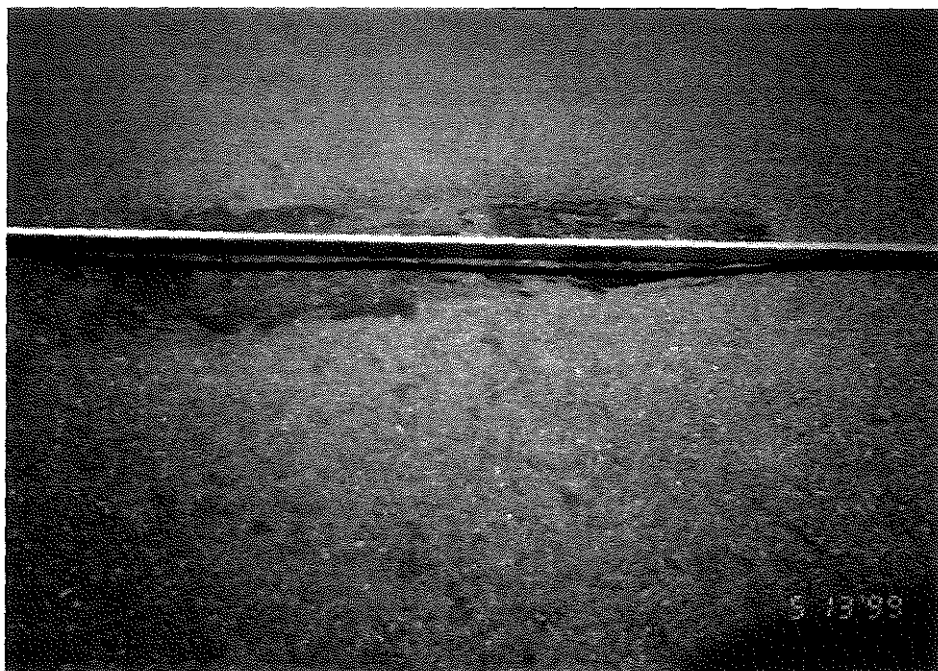
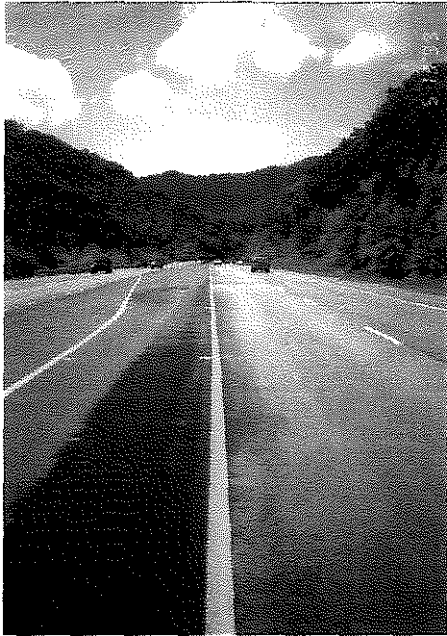
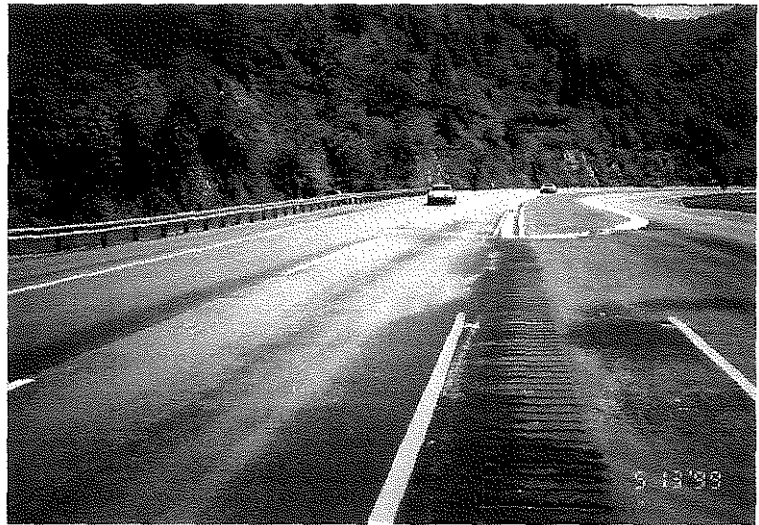
Figure 41. US 23, Pike Co.

This project was completed in November, 1998. The project was last inspected on May 13, 1999. Approximately 1/16 of an inch of rutting had occurred throughout the project. An isolated base failure was observed which was affecting the overlying pavement structure (Figure 41). Water was observed coming up through the pavement between Milepoints 12.7 to 14.0 (Figures 42 and 43).

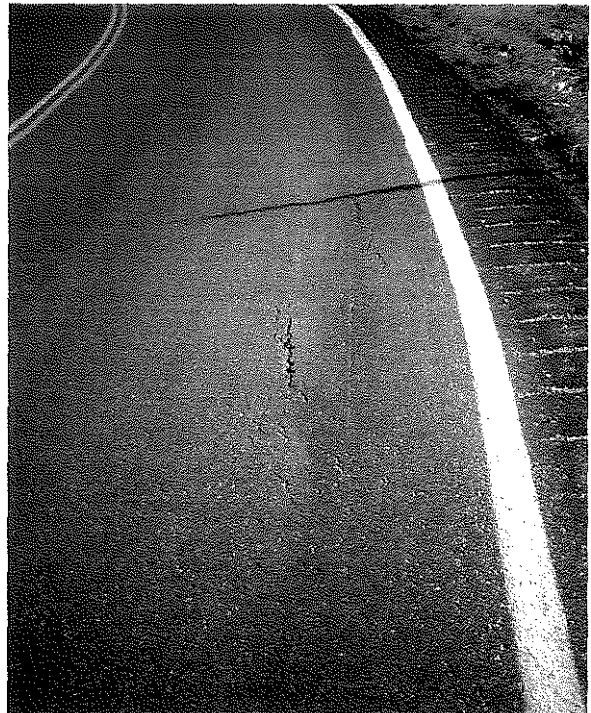
This project was completed in September, 1998. The project was last inspected on May 21, 1999. Longitudinal cracking was observed at the edge of the pavement in three locations (Figure 44). It appears that some of the longitudinal cracking may be due to a possible failure in the subgrade. Rutting ranged from 1/16 to 1/8 of an inch.

Figure 44. Longitudinal Cracking, Possible Base Failure (KY 550).

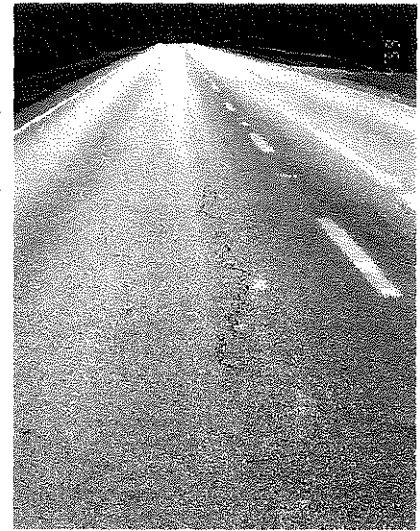
Figure 45. KY 15, Perry County.

The project was completed in 1997 and last inspected on May 5, 1999. Approximately 1/16 to 1/8 of an inch rutting had occurred throughout the project. Longitudinal and transverse cracking was observed in numerous areas throughout the project. Longitudinal cracking is shown in Figure 45.

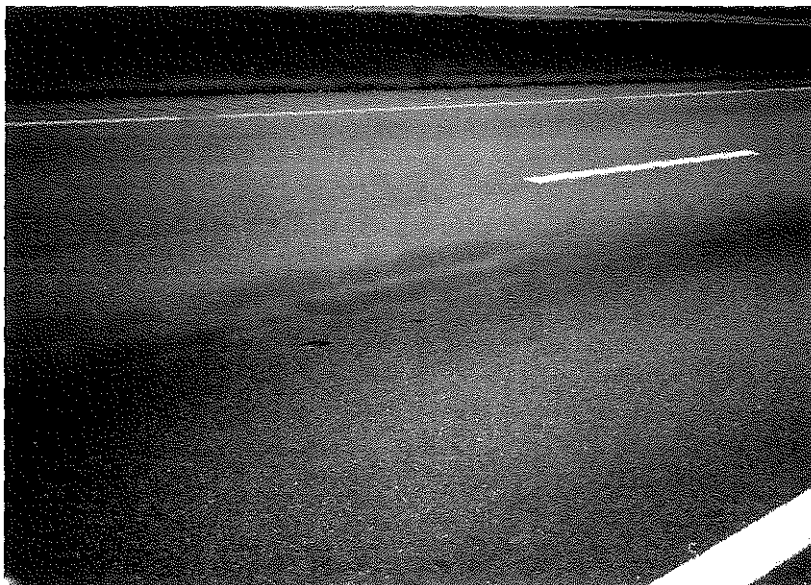
Figure 46. I-75, Laurel County.

The project was completed in 1997 and was last inspected on May 5, 1999. Bleeding was observed in the southbound lane in many areas (Figure 46). Rut measurements were not obtained due to traffic.

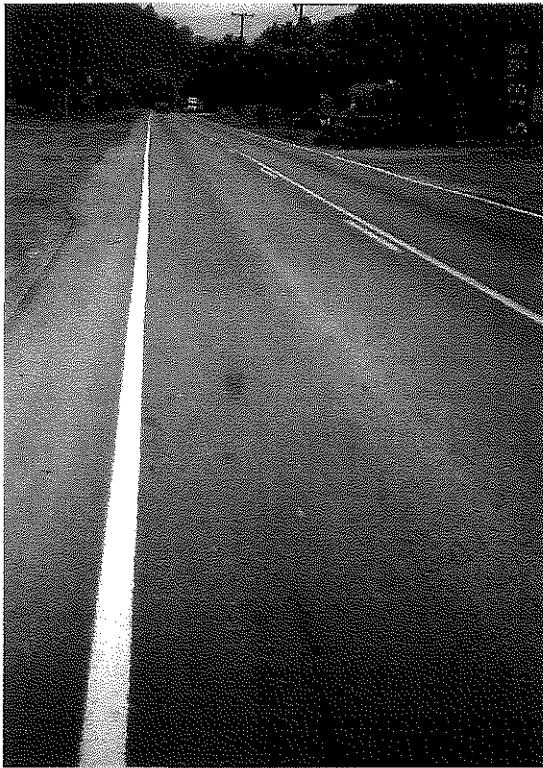
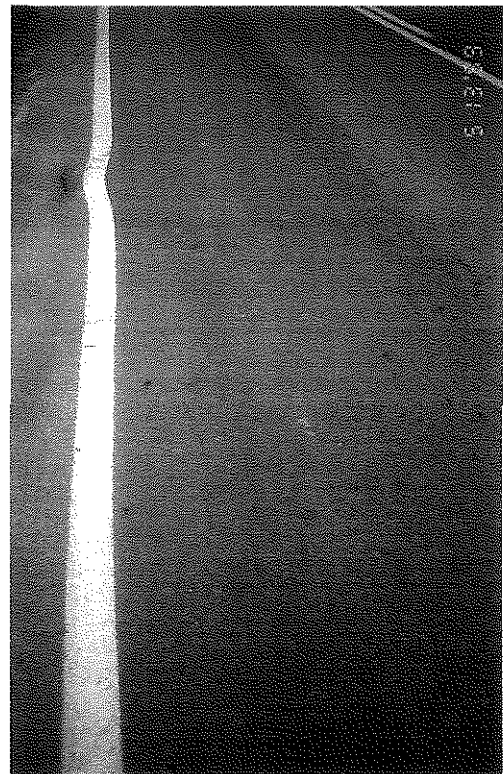
Figure 47. US 119, Pike Co.

The project was completed in June, 1998. It was last inspected on May 13, 1999. The project had more than average rutting. The average rut depth ranged from 1/8 to 3/16 of an inch. Several small spots of bleeding and longitudinal cracks were observed. Longitudinal cracks were observed along the pavement edge (Figures 47 and 48).

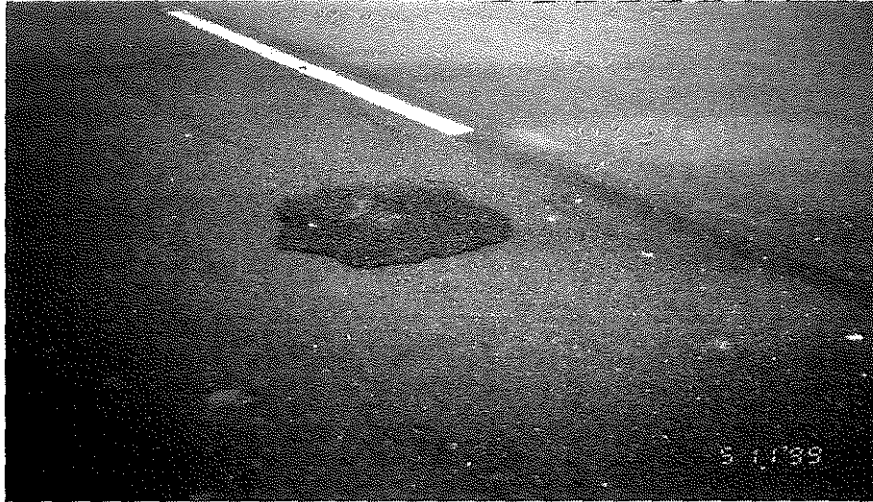
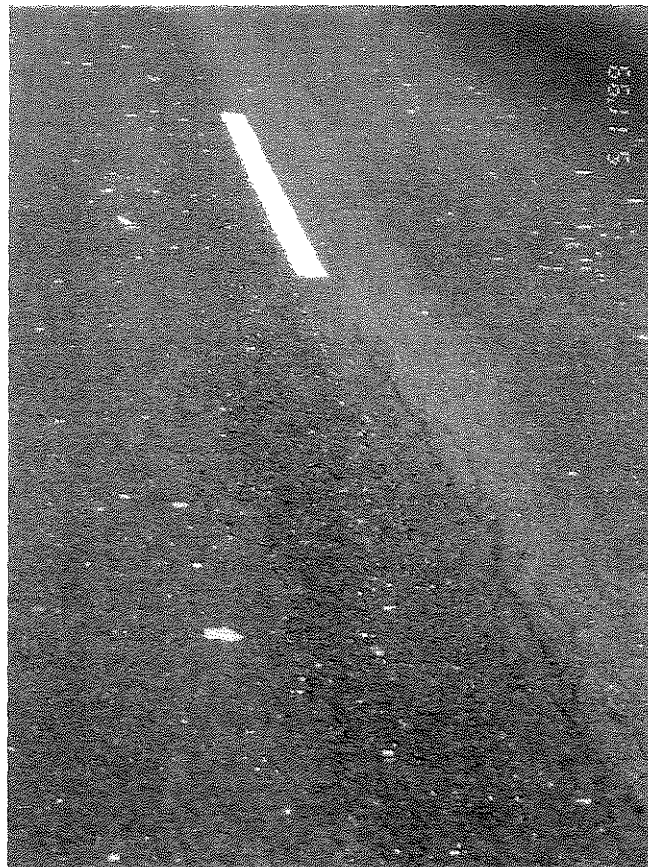
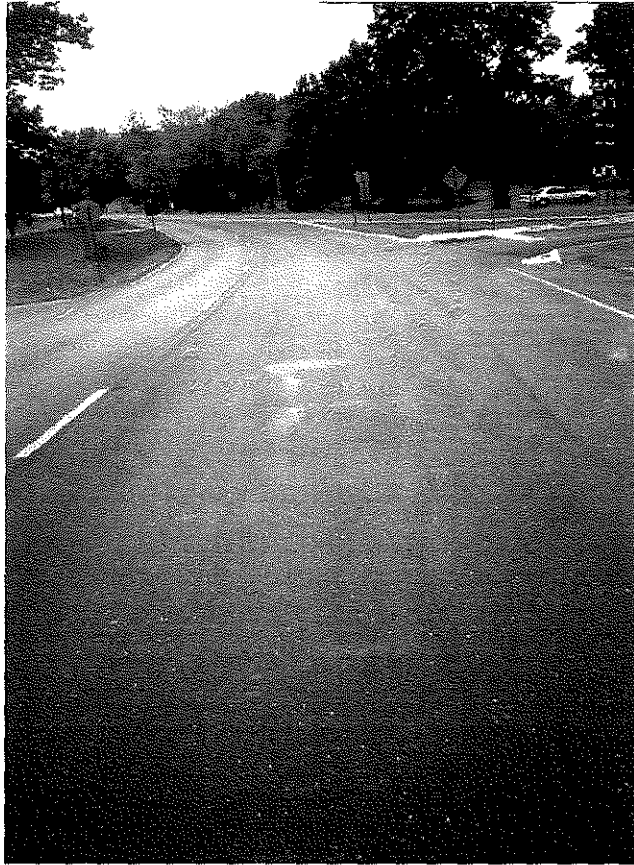
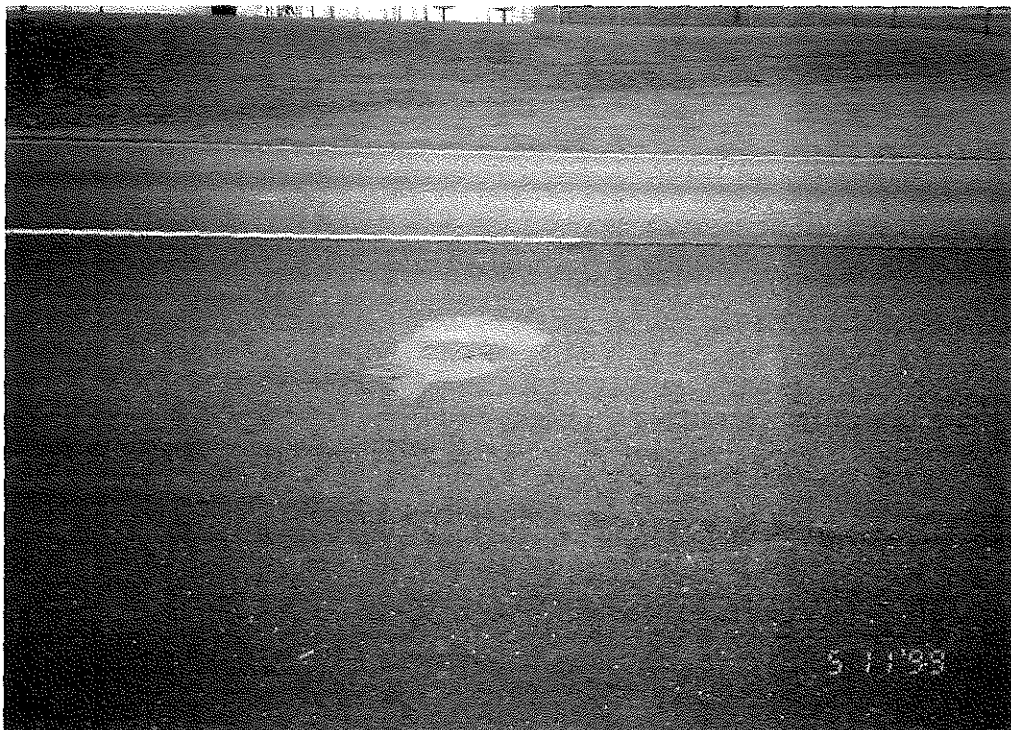
Figure 49. US 641N, Marshall Co.

US 641N was completed in 1997 and inspected on May 11, 1999. Several different types of distresses were observed throughout the project. Distresses included transverse cracking, longitudinal cracking, bleeding, and potholes (Figures 49-52).
